SALT LAKE CITY STREAMS, UTAH

LITTLE DELL LAKE
FOUNDATION REPORT

APRIL 1995

U.S. ARMY CORPS OF ENGINEERS
SACRAMENTO DISTRICT
SACRAMENTO, CALIFORNIA

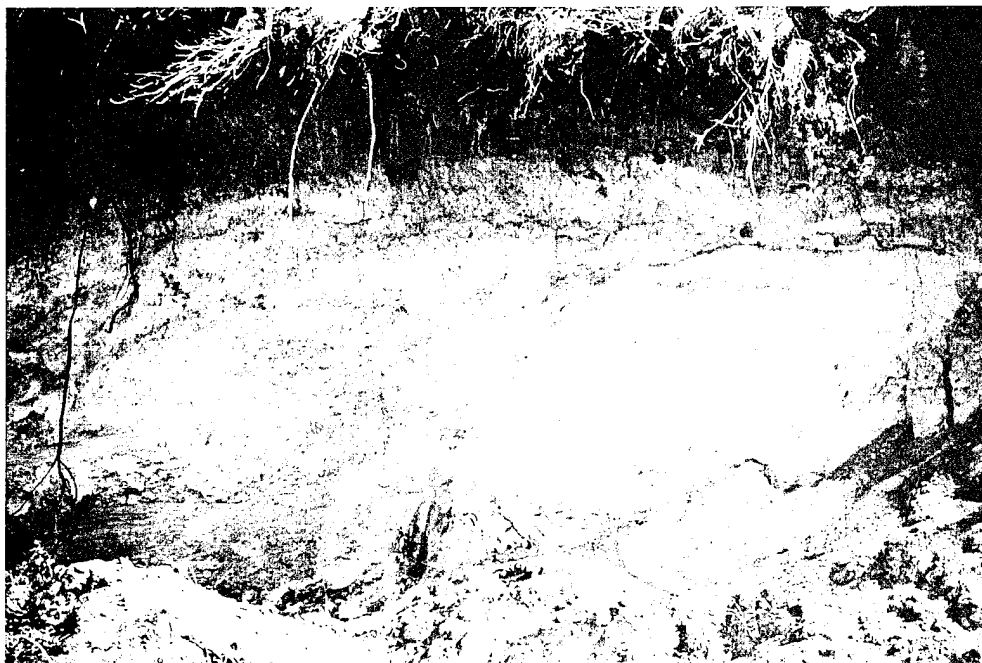
PHOTO GF3. Shear logged in 4F-19.

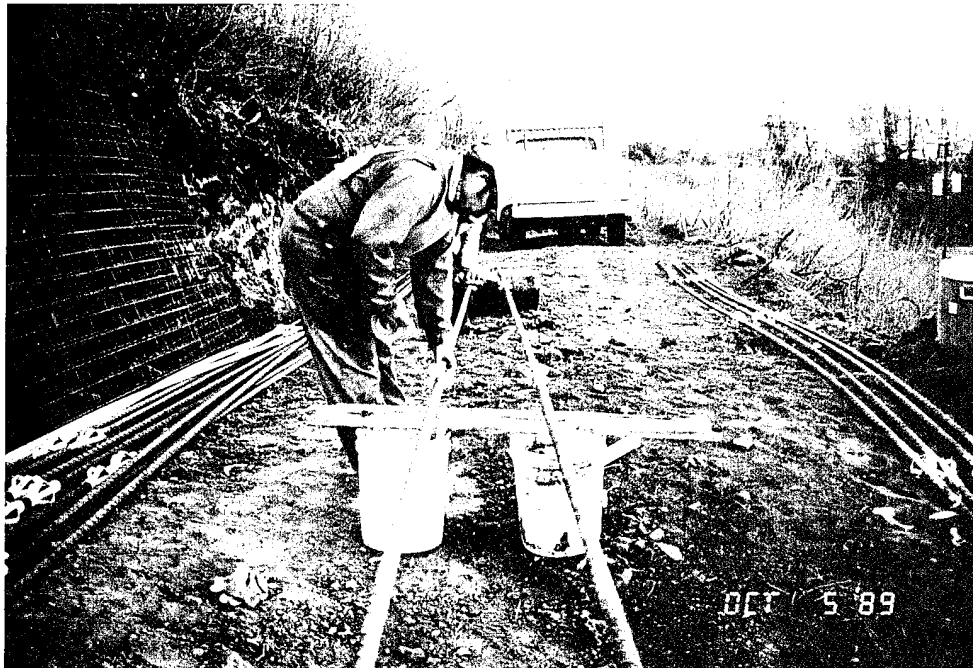
PHOTO P13. Taping centralizers to anchor bars before installing them.

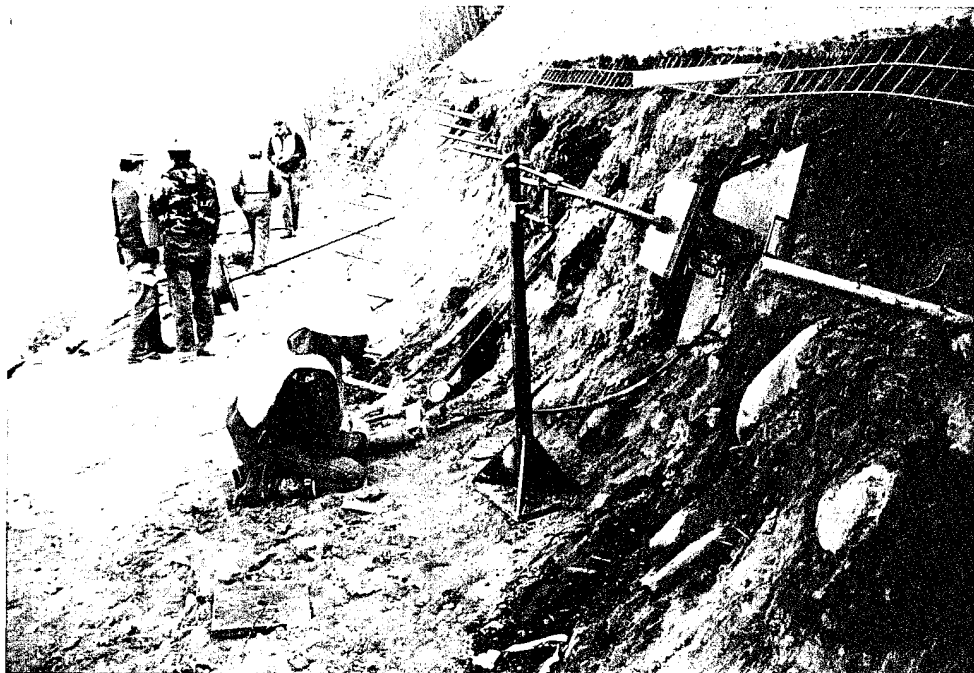
PHOTO P15. Performing a pull-out test on an anchor installed at the downstream portal.

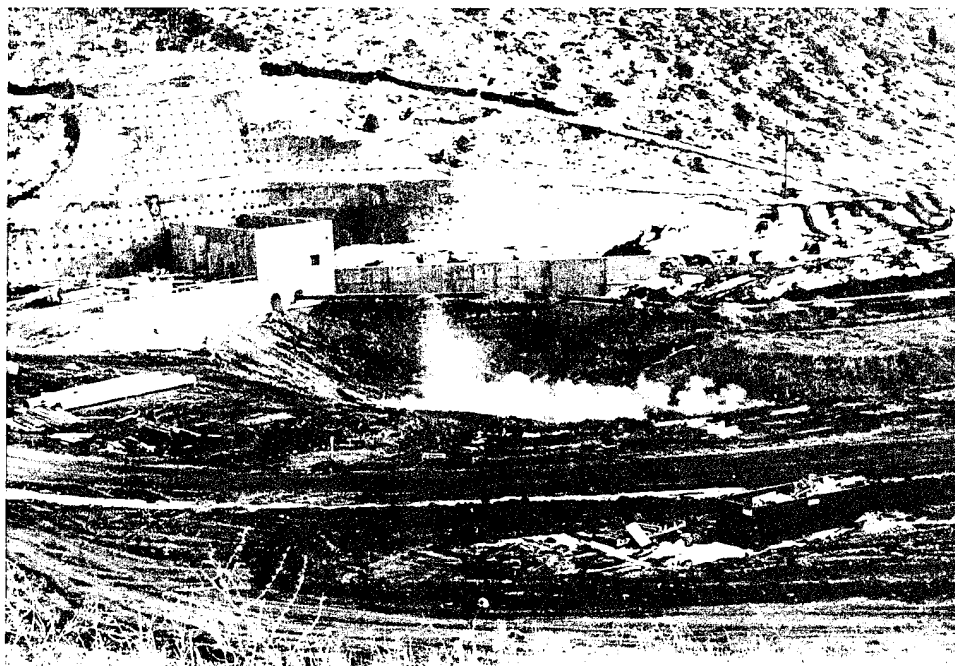
**Photo D1 (DOCS).** View of the downstream Outlet Works area, looking southeast, as a round is blasted to excavate hard rock in the bottom of the Plunge Pool.

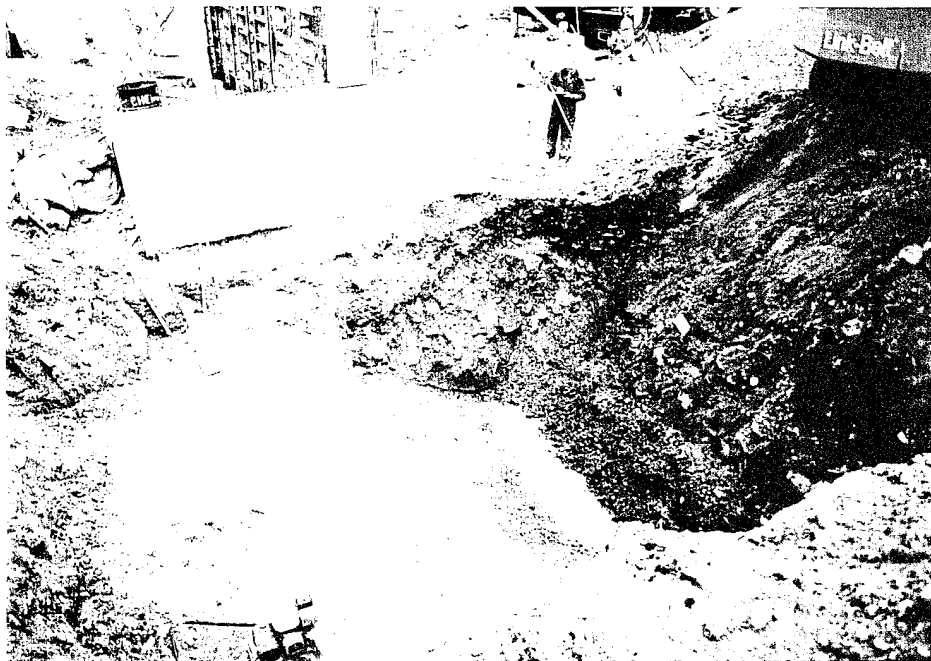
PHOTO D4. Looking south at the foundation for the north wingwall at the DOCS.

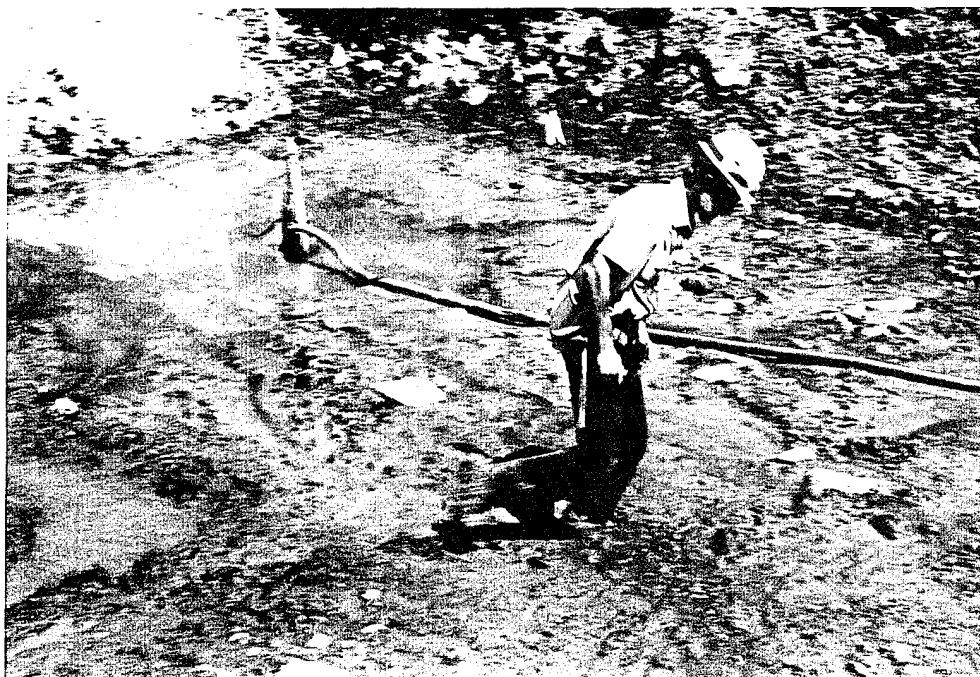
**PHOTO PC2.** Foundation of the downstream right half of the structure continued to deteriorate until all the alluvium was removed, in part because the Contractor could not control ground water.

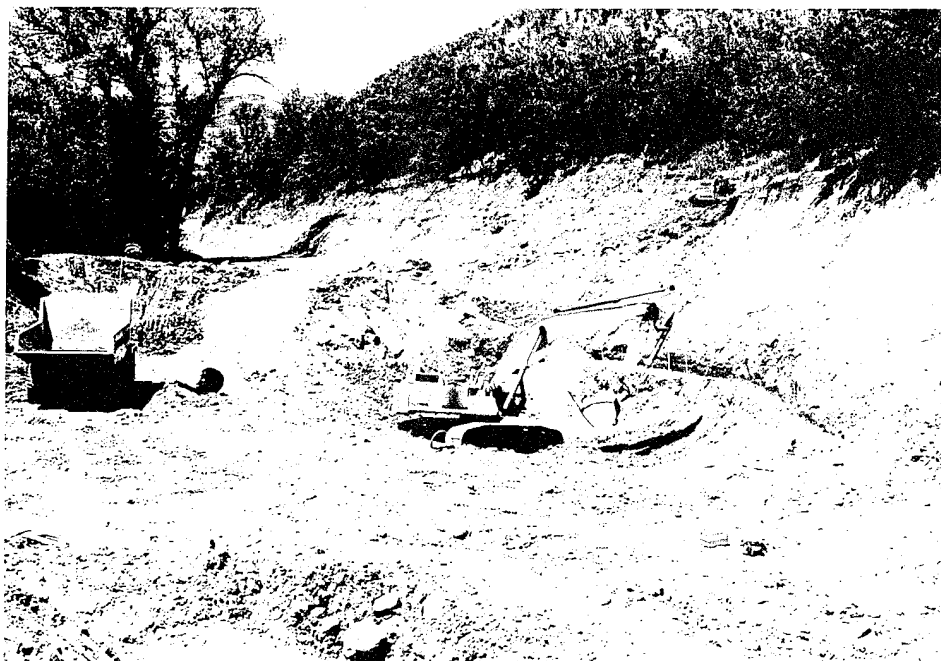
**PHOTO PC3.** All the loose material was excavated from the area in the previous photo and firm bedrock of the Kelvin Formation was exposed.

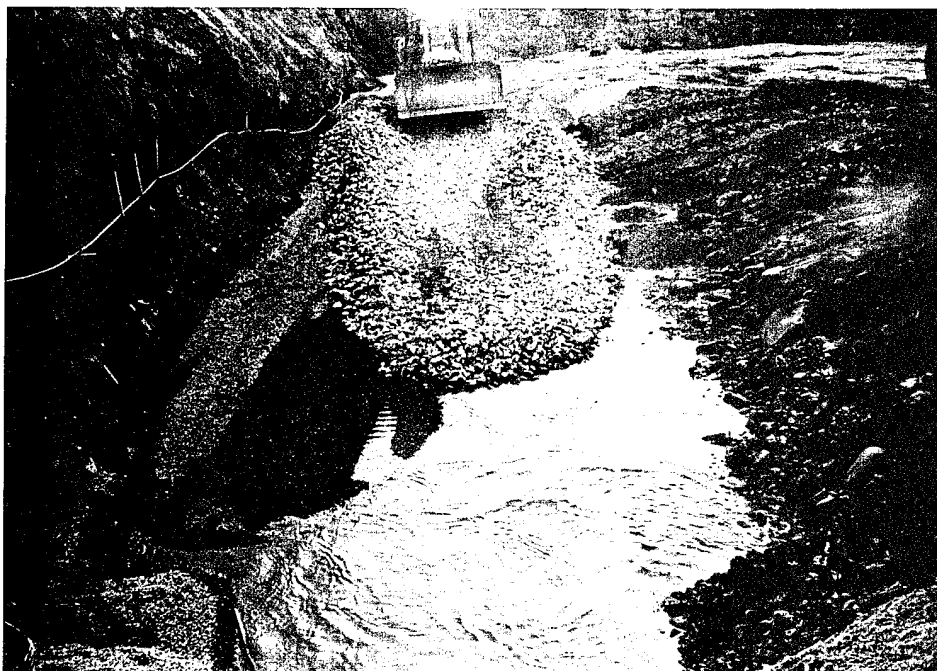
**PHOTO PC4.** After overexcavating to remove the soft, saturated alluvium, the foundation was brought back up to grade with angular gravel and cobbles.

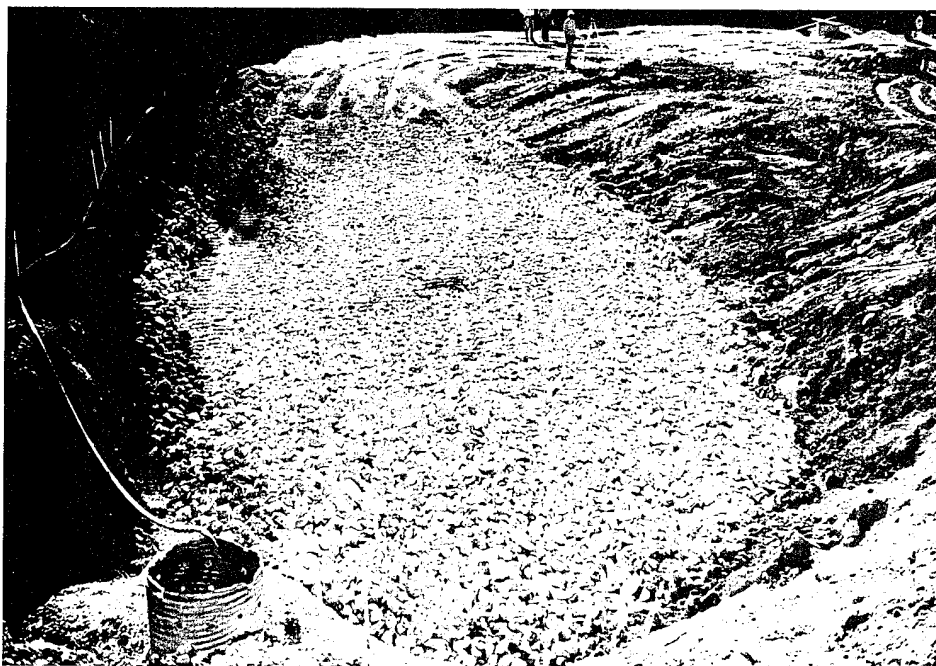
**PHOTO PC5.** The foundation at the downstream right corner of the diversion structure as approved.

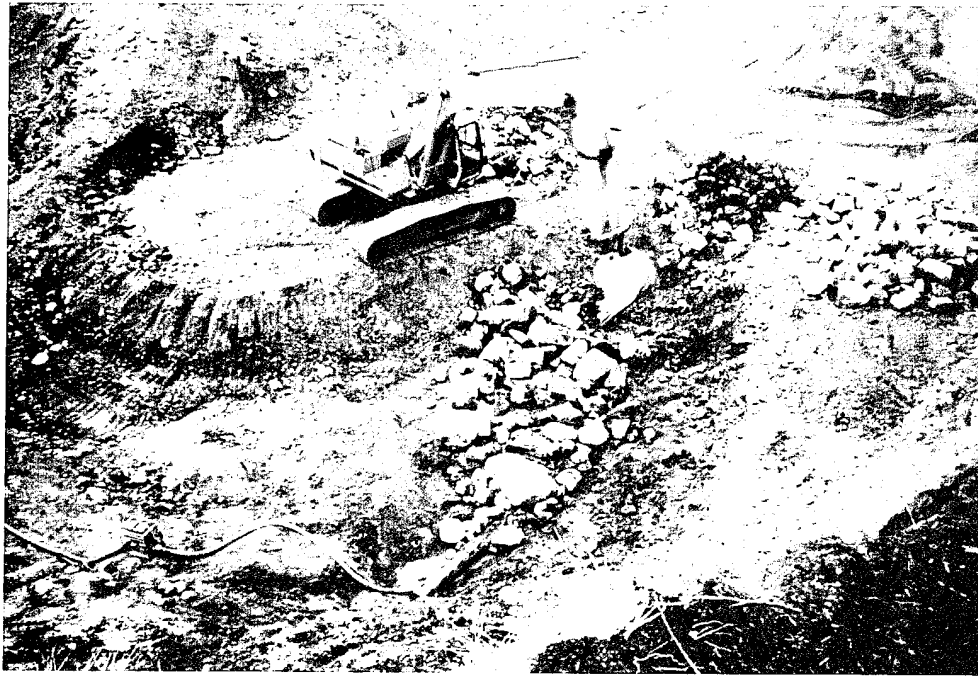
**PHOTO CC3.** Constructing a drain to de-water at the cut-and-cover conduit foundation. A 12-inch diameter perforated pipe was covered with boulders and cobbles then chinked with smaller rock.

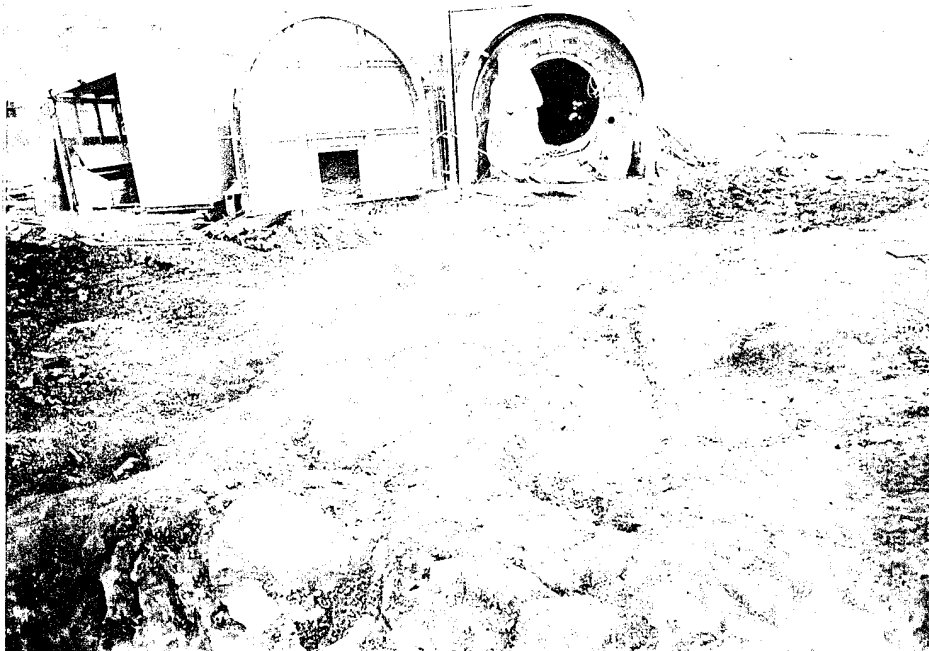
**PHOTO CC4.** View of the foundation for engineered fill under the downstream end of the Outlet Works cut-and-cover conduit. Photo looks downstream toward the upstream portal.
